Sailors and Marines Preventing Mishaps **BRAVO Zulu**

BZ
of the
Quarter

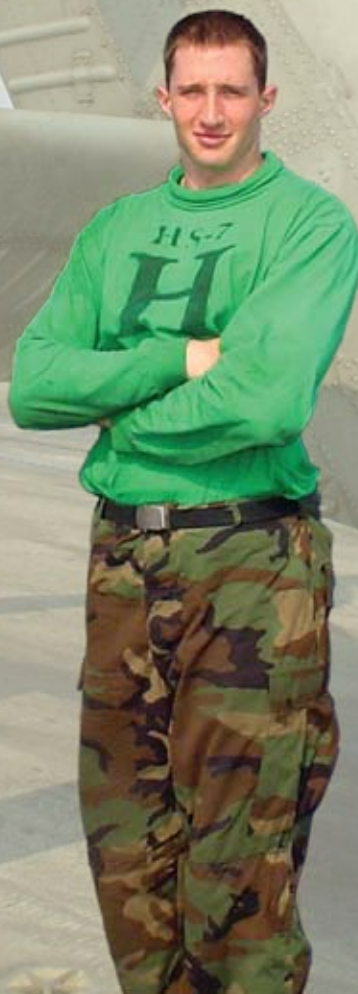
AMAA Ryan Marshall HS-7

While doing a turnaround inspection on aircraft 617, airman apprentice Marshall determined one of the tail-rotor blades felt loose, compared to the others. He did a “teeter test,” which checks for spar integrity and a delaminating tail rotor. He then found a few cracks near the blade cuff and notified QA. After removing the outboard retention plate, a QAR found the composite fiber layers of the blade spar had started to separate from each other, causing the tail rotor spar to crack along the retention plate. Had the delamination and cracks gone unnoticed, the tail-rotor blade likely would have failed during the next flight.
